**DEPARTMENT OF TRANSPORTATION****DIVISION OF ENGINEERING SERVICES**

Contract #: 04-0120F4Cty: SF/ALA Rte: 80 PM: 13.2/13.9File #: 69.28**WELDING INSPECTION REPORT****Resident Engineer:**Pursell, Gary**Address:** 333 Burma Road**City:** Oakland, CA 94607**Report No:** WIR-005426**Date Inspected:** 07-Feb-2009**Project Name:** SAS Superstructure**OSM Arrival Time:** 700**Prime Contractor:** American Bridge/Fluor Enterprises, a JV**OSM Departure Time:** 1900**Contractor:** Zhenhua Port Machinery Company, Ltd (ZPMC), Changxing Island **Location:** Shanghai, China**CWI Name:** Luan Zhao Gang**CWI Present:** Yes No**Inspected CWI report:** Yes No N/A**Rod Oven in Use:** Yes No N/A**Electrode to specification:** Yes No N/A**Weld Procedures Followed:** Yes No N/A**Qualified Welders:** Yes No N/A**Verified Joint Fit-up:** Yes No N/A**Approved Drawings:** Yes No N/A**Approved WPS:** Yes No N/A**Delayed / Cancelled:** Yes No N/A**Bridge No:** 34-0006**Component:** OBG segment**Summary of Items Observed:**

OBG outside assembly (OBG segment 3BE)

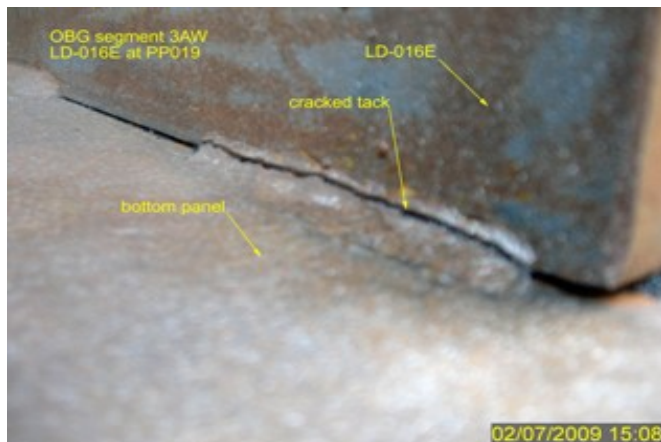
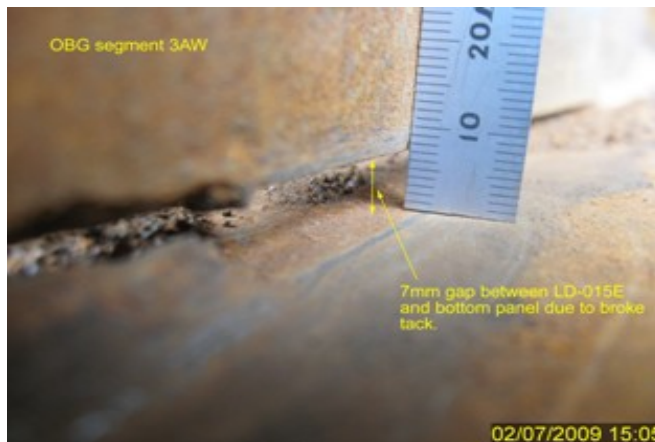
This QA observed two cracked tack welds joining longitudinal diaphragms identified on the material as LD-015A and LD-016A to the bottom panel. These diaphragms are located on the out board side of floor beam at PP019. The tacks in question are located at the end of the joint past where ZPMC had terminated the weld joining the diaphragm to the bottom panel. ZPMC QC Certified Welding Inspector (CWI) identified as Mr. Luan Zhao Gang and ABF inspector identified as Mr. Wang Heng informed this QA that these tack welds will be repaired after the contractor joins this segment to its mating segment and completes the weld that has been intentionally left short to facilitate the fit up and welding of the mating segment. See attached photos.

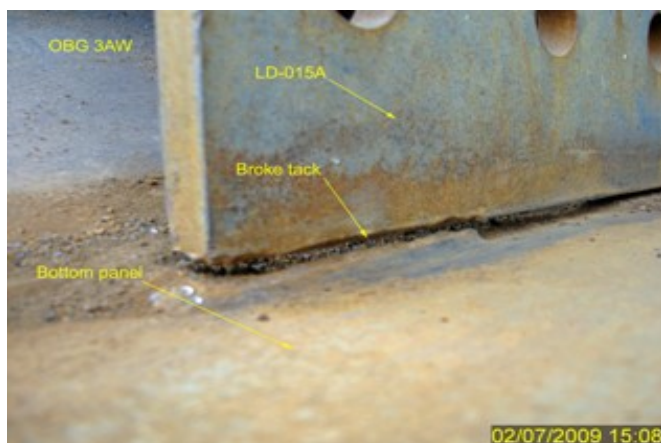
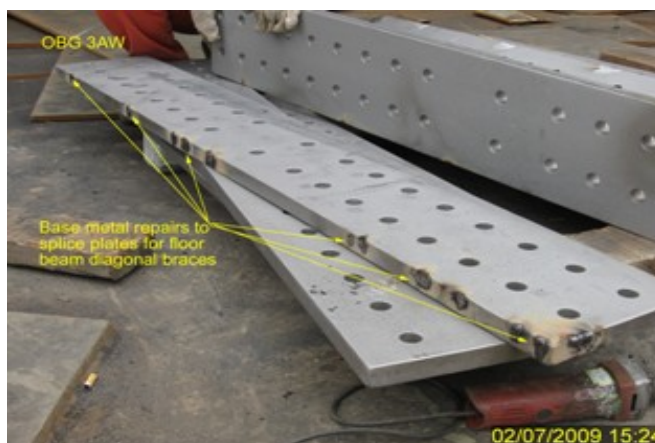
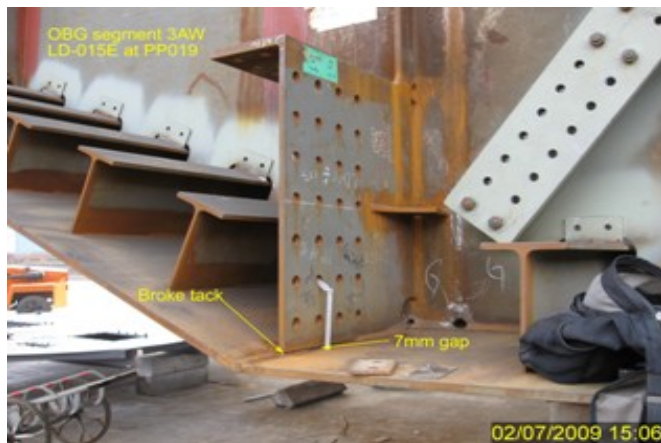
This QA observed ZPMC personnel grinding what appeared to be base metal edge weld repairs on connection plates for the floor beam diagonal bracing. There appeared to be four connection plates that had been repaired. ZPMC QC informed this QA that the repairs were needed in order to correct nicks and gouges in the edge of the plates created during the flame cutting process. See attached photo.
